ENVIRONMENTAL ISSUES OF ARTISANAL AND SMALL-SCALE MINING IN THE TARKWA MINING AREA OF GHANA

N. K. Dumakor-Dupey, Univ. of Mines and Tech., Tarkwa, Ghana
K. J. Bansah, Missouri Univ. of Science and Tech., Rolla, MO

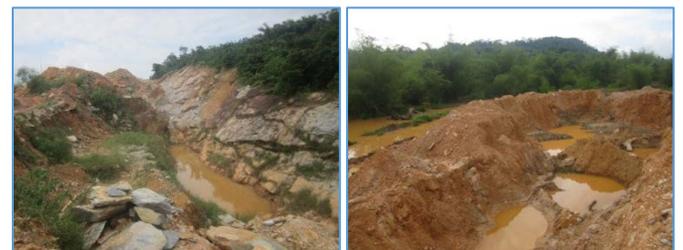
Figure 2. Abandoned ASM Pits in the Tarkwa Area.

Degradation of vegetation and land is common in places where ASM occurs. This issue is more critical in areas affected by illegal mining activities. Illegal ASM is nomadic with diggers abandoning excavated sites for new areas in search for gold. As a result, large areas of forest cover get depleted. Large open pits abandoned by diggers also serve as fall traps to farmers, hunters, children and wildlife (see Figure 2). These pits are often filled with water, serving as potential breeding grounds for mosquitos which are a major health (malaria) concern.

Mitigating adverse environmental impact of ASM requires education, technical training of diggers, regulatory enforcement, and policies that involve participation of local communities and diggers in decision making. Lack of education and technical training of the diggers contribute to the environmental issues. This is because, improper mining processes are typically adopted without much regard for environmental preservation. It is important for authorities responsible for ASM in the country to organize educational and training programs for licensed operators to improve their mining methods and ensure environmental protection.

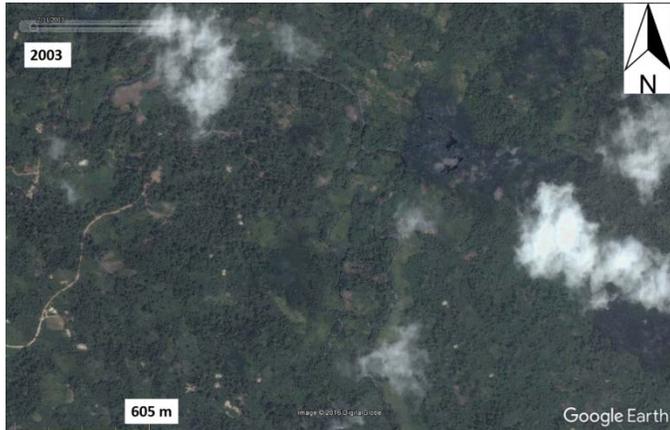
Figure 3. Undisturbed Forest Area near Nsuaem (2003).

ASM has the potential to threaten forest resources in the country. For instance, an undisturbed forest zone around the Nsuaem area has been affected significantly by ASM activities. Historical images (Figures 3 and 4) obtained from Google Earth show devastation caused by ASM in the vicinity of Nsuaem between 2003 and 2015. Degradation of forest can lead to displacement of wildlife, habitat loss, and ecological imbalance that affect biodiversity of the ecosystem. Loss of arable lands and deterioration of aesthetic nature of landscape are also typical in ASM affected areas. Studies conducted by other researchers indicated that mining has impacted significantly on vegetation cover in the Tarkwa area (Kumi-Boateng *et al.*, 2011; Kusimi, 2008). These studies, however, did not indicate the type of mining (either large-scale or ASM) that has impacted vegetation in the

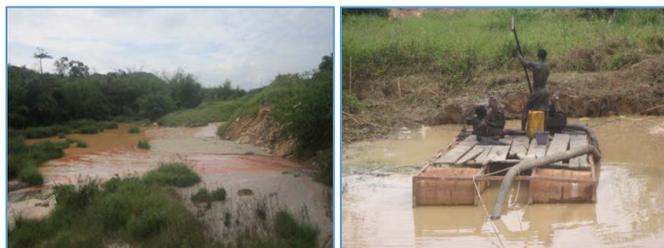
Figure 5. Streams Affected by ASM.

ASM depends on large quantities of water for sluicing. Stream/river courses are sometimes diverted into ASM sites, depriving downstream users from their source of water. In some instances, effluents are directly released into the water system without any form of treatment, impacting on aquatic life and endangering the lives of people who depend on the water as their source of drinking water. In other cases, materials are directly washed in the waterbodies. Water quality could be affected by increasing turbidity, suspended solids level and dissolved solids concentration. Heavy metals can also be released into the water through ASM activities. Further, dredging for gold in and around rivers and streams can impact heavily on water quality. Affum *et al.* (2016) collected water samples and river sediments from the Bonsa River located near Tarkwa, and analyzed for heavy metal concentrations. They found high levels of mercury in the river sediments and attributed the situation to ASM activities in the river. Two different streams affected by ASM through effluent discharge and dredging are shown in Figure 5.

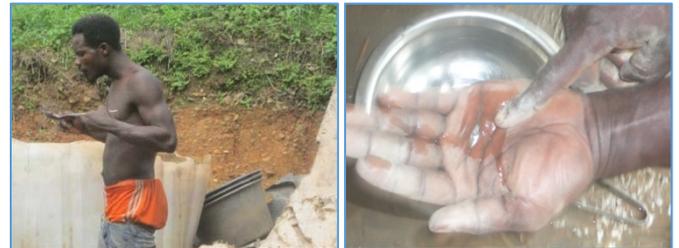
ASM operators in Ghana generally use mercury for amalgamation. Due to improper handling (Figure 6), mercury losses occur at the ASM sites. In a previous study, Bansah *et al.* (2016a) document some of the ways by which mercury losses can occur in ASM. In this present study, we observed that many diggers are oblivious of the harmful effect of mercury. The few enlightened ones usually ignore precautionary measures when handling mercury. The situation could be attributed to lack of education and technical training. It is important to acknowledge that some licensed ASM operators provide PPE for their workforce. However, many workers avoid using the PPE, stating that using PPE makes them uncomfortable.

Figure 6. Miners Handling Gold Amalgam: On the left, a digger places gold amalgam in a metallic ladle with charcoal fire and fans it by blowing air with the mouth. On the right, a miner places mercury in the bare palm.
